# ECO S och ECO M

## kvalitetsavvikelse

# ECO S and ECO M

## Quality deviation

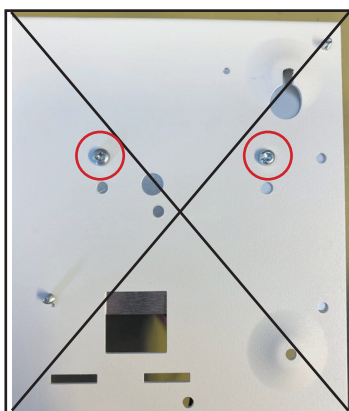
Vid slutmontering har komponenten nättaggregat skruvats i skåpets baksida (bild 1) istället för insidan av kapslingen. Detta ger en risk att skyddsjordningen av komponenten inte fungerar som avsett.

Komponenten, nättaggregatet kan då få en potentialskillnad mot inkommande skyddsjord. Detta kan leda till åtkomst av spänningsförande ytor på enbart på komponenten.

Avvikelsen påverkar ej enhetens funktion eller driftsäkerhet. Risk för stöt uppkommer vid samtidig beröring av komponenten nättaggregat och samtidig beröring av en skyddsjordad yta. Det är bara vid service, när luckan är öppen, som risk för mindre stöt kan uppstå. Denna stöt är ofarlig. En jordfelsbrytare löser ut vid 30 mA och uppmätt ström mellan nättaggregat och inkommande skyddsjord är ca 6 mA. Detta utgör ingen personsäkerhetsrisk men kan uppfattas obehagligt.

Bild 1: Enhets baksida med felaktigt monterat nättaggregat (utan taggbricka).

Ja, skrupåse med instruktion finns att tillgå kostnadsfritt, kontakta support för mer information.

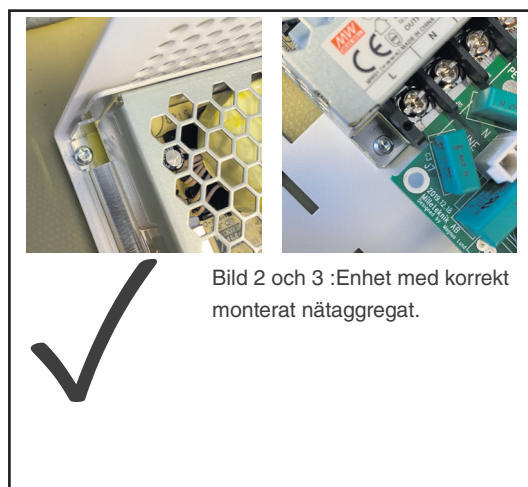
Bild 2 och 3 :Enhet med korrekt monterat nättaggregat.

Åtgärder är vidtagna för att avvikelsen ej skall uppkomma igen med utbildning, förbättrade instruktioner för korrekt montering (bild 2 och 3) av nättaggregat samt utökade stickprovskontroller.

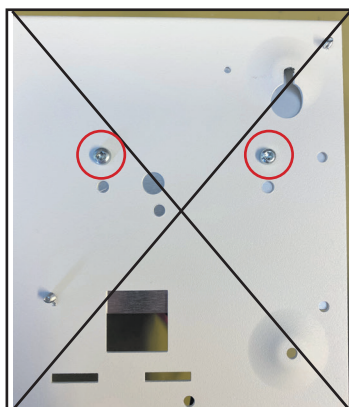
At final assembly, the component power supply has been screwed into the back of the cabinet (Figure 1) instead of the inside of the enclosure. This poses a risk that the protective earth of the component does not work as intended.

The component, the power supply, can then have a potential difference to the incoming protective earth. This can lead to access of live surfaces only on the component.

The deviation does not affect the unit's function or operational reliability. Risk of shock arises when simultaneously touching the power supply component and simultaneously touching a protective earthed surface. It is only during service, when the door is open, that there is a risk of minor shocks. This shock is harmless. An earth fault circuit breaker trips at 30 mA and the measured current between the power supply and the incoming protective earth is approximately 6 mA. This does not pose a personal security risk but can be perceived as unpleasant.

Figure 1: Unit back with incorrectly mounted power supply (without tag washer).

Yes, screw bag with instructions is available free of charge, contact support for more information.

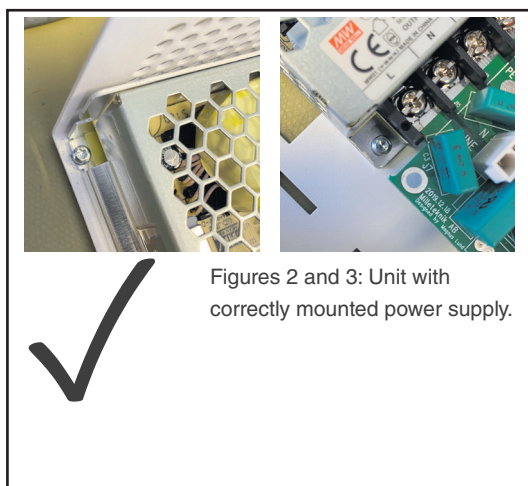
Figures 2 and 3: Unit with correctly mounted power supply.

Measures have been taken to ensure that the deviation does not recur with training, improved instructions for correct installation (Figures 2 and 3) of power supplies and extended random checks.
